INDOOR AIR QUALITY REASSESSMENT

**Lynnhurst Elementary School
443 Walnut Street
Saugus, Massachusetts**

Prepared by:
Massachusetts Department of Public Health
Center for Environmental Health
Emergency Response/Indoor Air Quality Program
June 2006

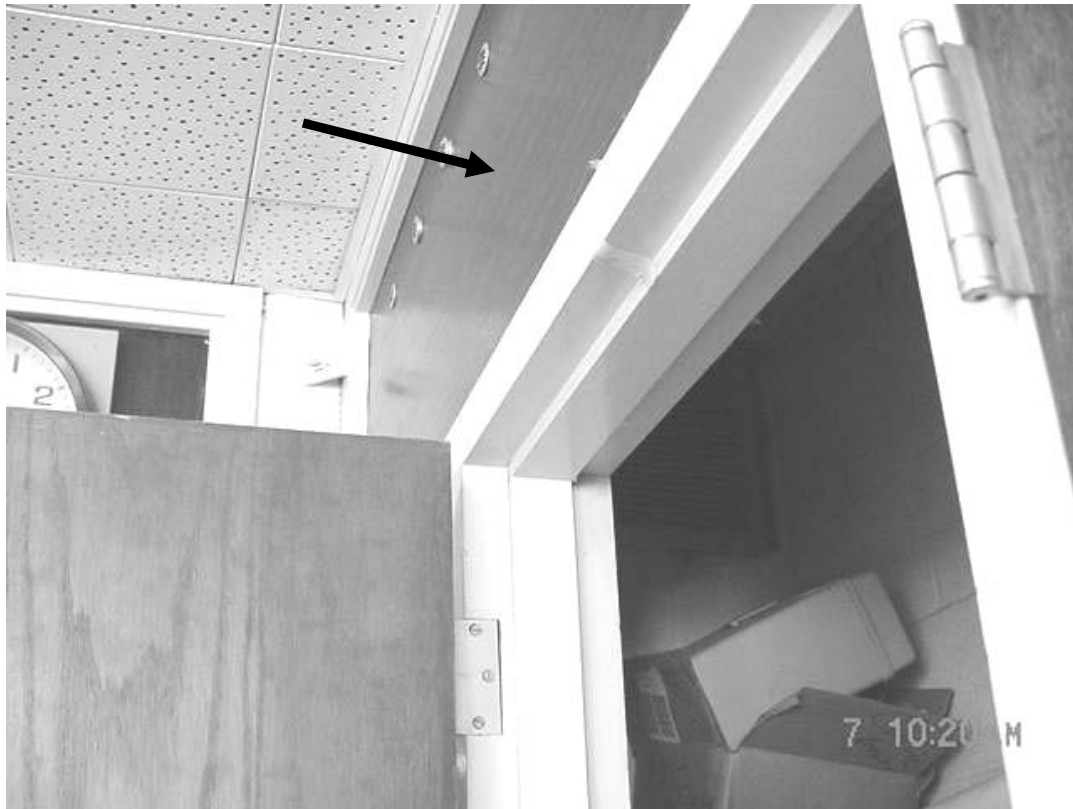
Picture 1

The design of the mechanical exhaust ventilation system in classrooms is such that classroom air must be pulled beneath the doors of coat closets through a grill located in the top of the coat closets, powered by rooftop motors. Air is drawn into the coat closet from the classroom via undercut closet doors. The location of these closet vents allows them to be blocked by stored materials. Mr. Macero and Mr. Materissi, discussed the installation of a ducted grill on the face of the coat closet (Picture 1), which would

Arrow Indicates Recommended Location on Front Face of Coat Closet for Ducted Exhaust Grill

draw exhaust directly from the classroom. This modification in combination with the continuous operation of univents and/or the opening of classroom windows should enhance air circulation.

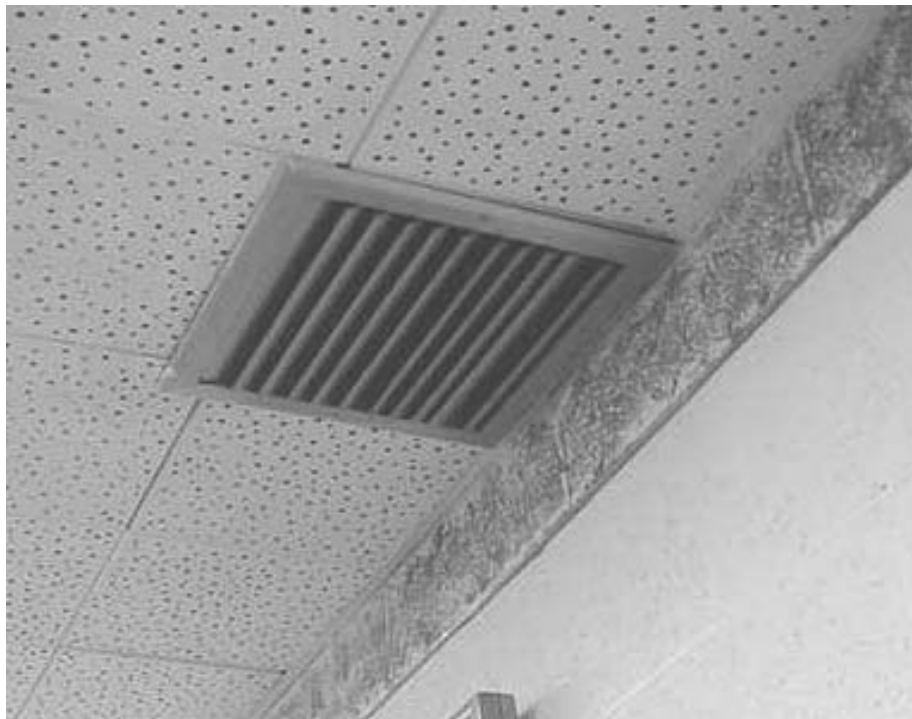
Picture 2

The main office, library, teacher's lounge, and the resource room (next to the library) had louvered ceiling vents (Picture 2). However no airflow (neither supply nor exhaust) could be detected from these vents, making it difficult to determine their function. The Nurse's office does not have a means of mechanical ventilation nor openable windows.

Ceiling Vent in Library

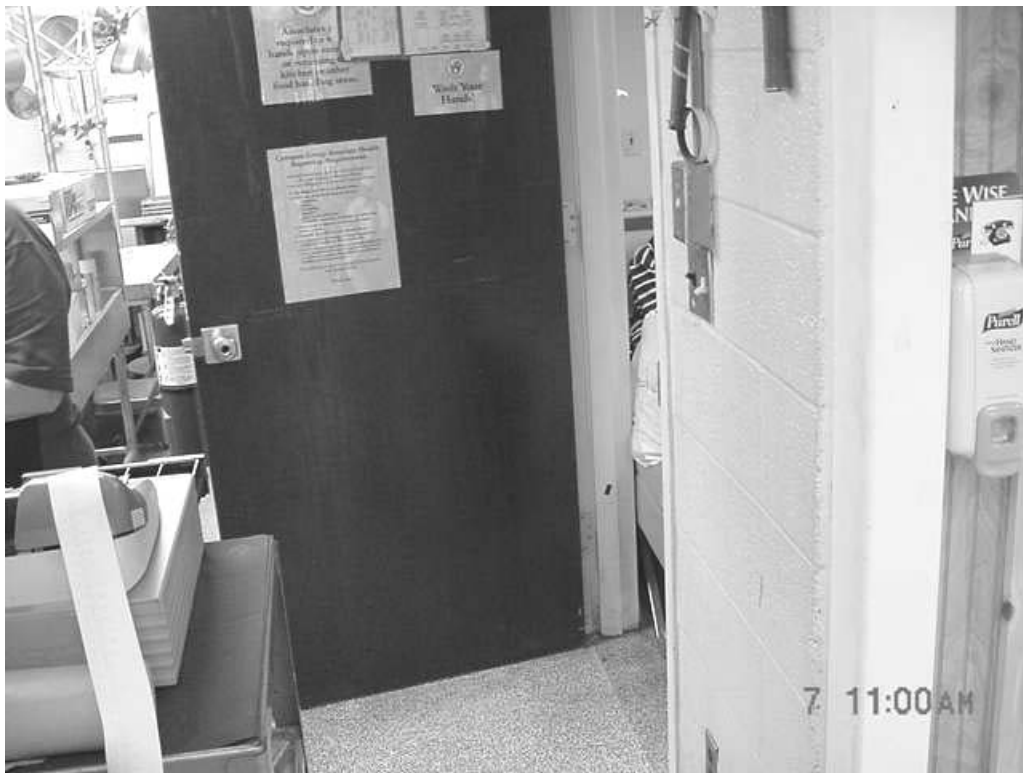
Picture 3

Kitchen Door to Nurse's Office Propped Open during Lunch Prep

11. Keep all doors to the kitchen and nurses office shut.
12. Contact an HVAC engineering firm to inspect the local exhaust hood in the kitchen for proper function and develop a preventative maintenance program for this equipment.

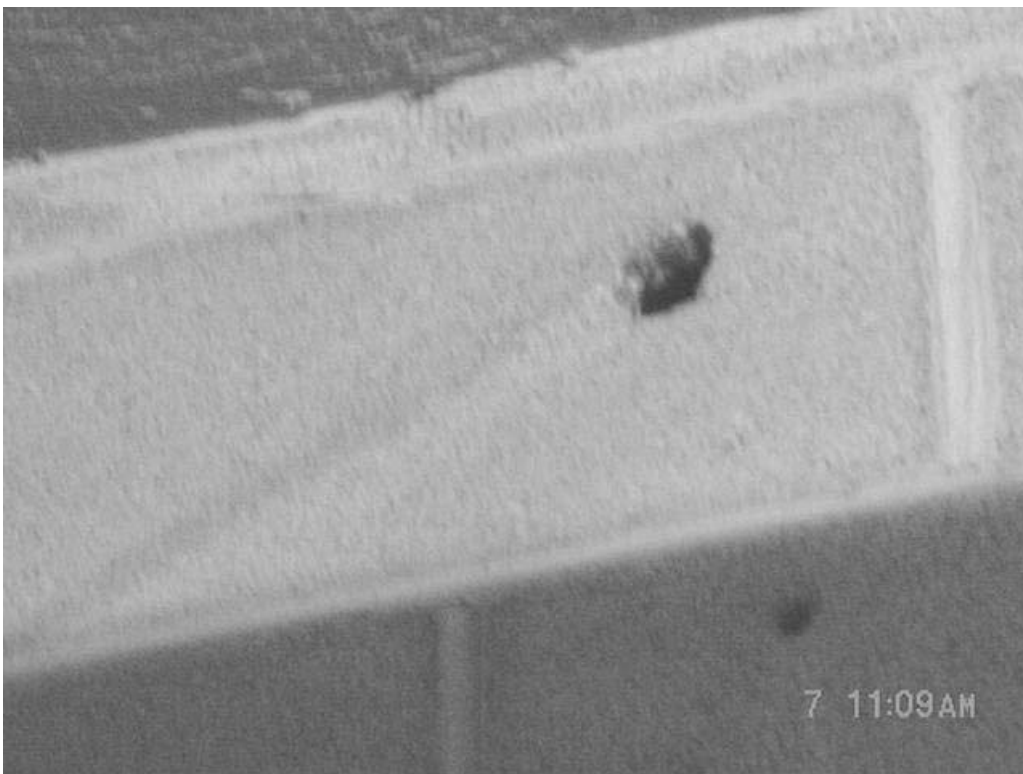
Picture 4

Open Utility Holes in Common Wall between Boiler Room and Nurse's Office

6. Continue with window replacement project.
7. Seal utility holes in boiler room and replace missing ceiling tiles in other areas of the building to prevent the migration of odors and/or particulates.

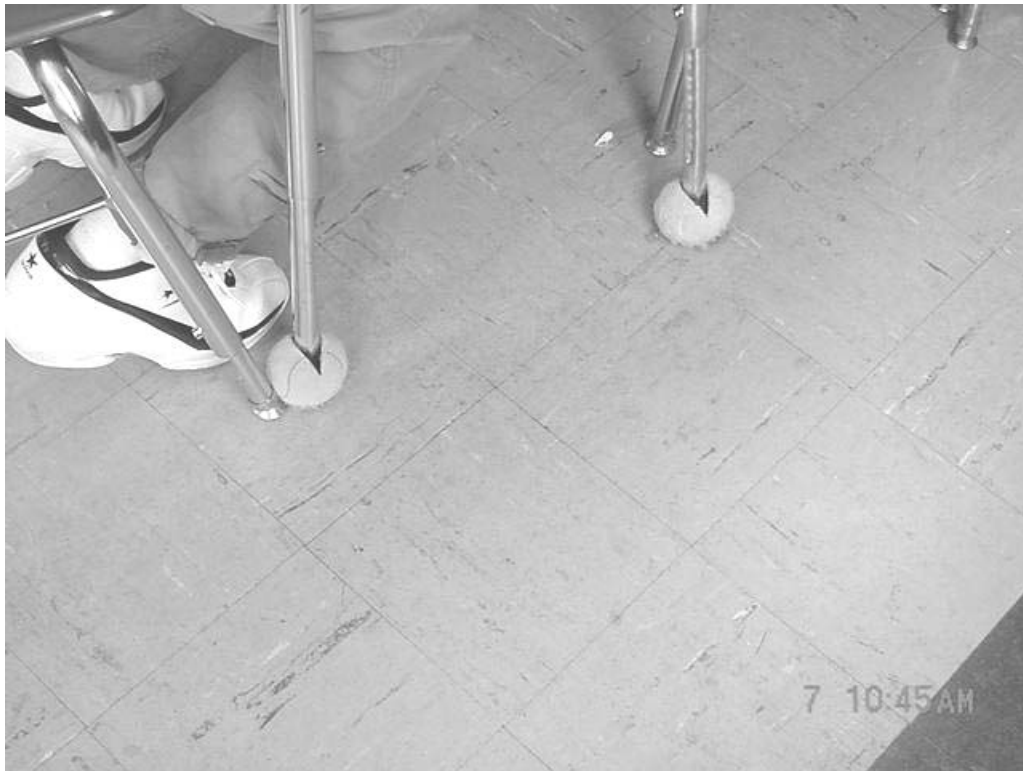
Picture 5

In an effort to reduce noise from sliding chairs, tennis balls had been sliced open and placed on chair legs (Picture 5). Tennis balls are made of a number of materials that are a source of respiratory irritants. Constant wearing of tennis balls can produce fibers and cause TVOCs to off-gas. Tennis balls are made with a natural rubber latex bladder, which becomes abraded when used as a chair leg pad. Use of tennis balls in this manner may introduce latex dust into the school environment. Some individuals are highly allergic to latex (e.g., spina bifida patients) (SBAA, 2001). It is recommended that the

Tennis Balls on Desk Legs in Classroom

use of materials containing latex be limited in buildings to reduce the likelihood of symptoms in sensitive individuals (NIOSH, 1997). A question and answer sheet concerning latex allergy is attached as Appendix C (NIOSH, 1998).

10. Consider discontinuing the use of tennis balls on furniture and replacing tennis balls with alternative "glides". Refer to Picture 6 for an example.
